Technical Service Bulletin

17-01-015

FEBRUARY 2017

**2017 ELANTRA (ADA) BRAKE BOOSTER REPLACEMENT
(RECALL CAMPAIGN 157)**

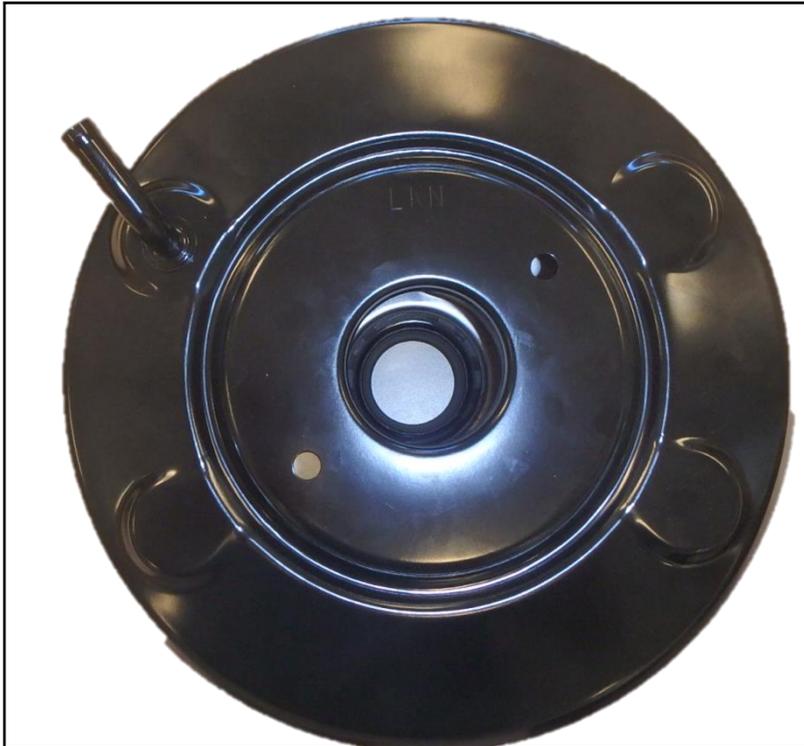
Description: On affected 2017 MY ADa Elantra sedans, the diaphragm in the brake booster may unseat, resulting in a vacuum leak and reduction or loss of power brake assist. A malfunctioning brake booster could increase stopping distances, increasing the risk of a crash. This bulletin describes the procedure to replace the brake vacuum booster.

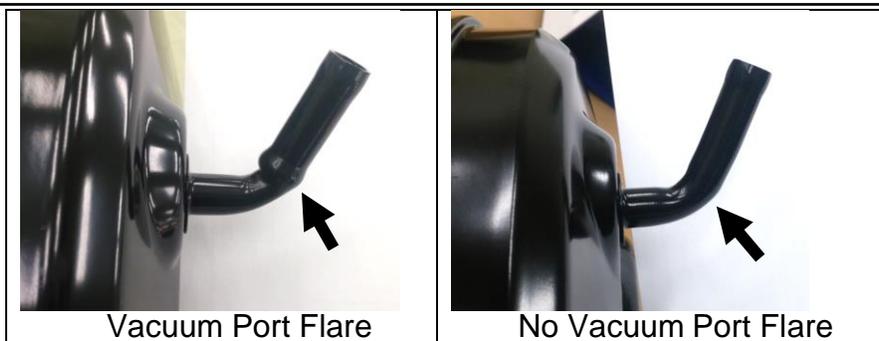
Some brake vacuum boosters may have a flared vacuum port. Brake vacuum boosters with either style vacuum port are interchangeable and can be used for this repair.
